A REPORT FOR THE WELL AT KIDSCARE PRIMARY SCHOOL ON 12TH SEPTEMBER 2021

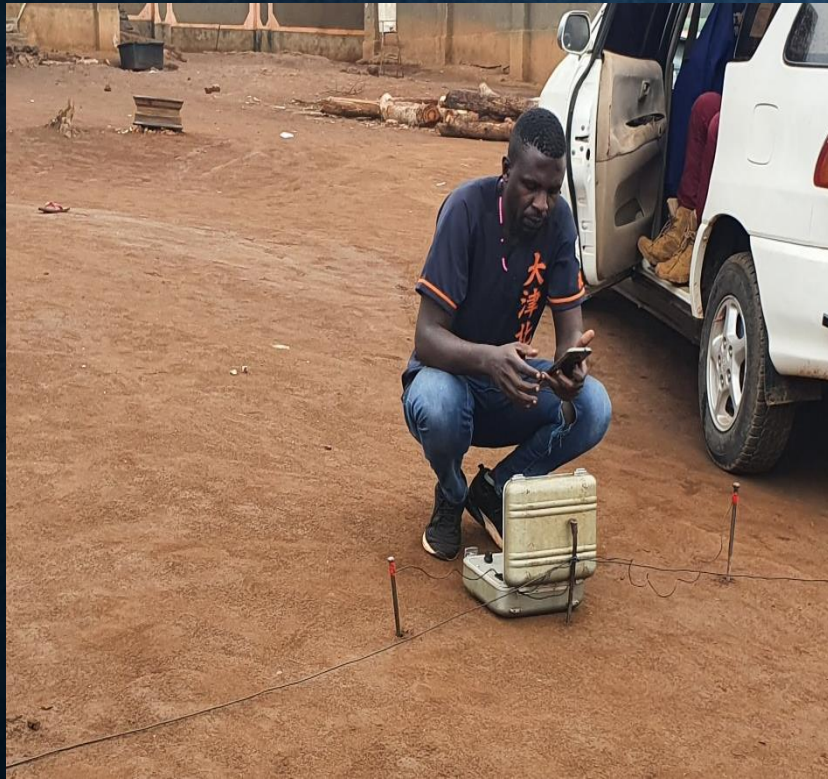
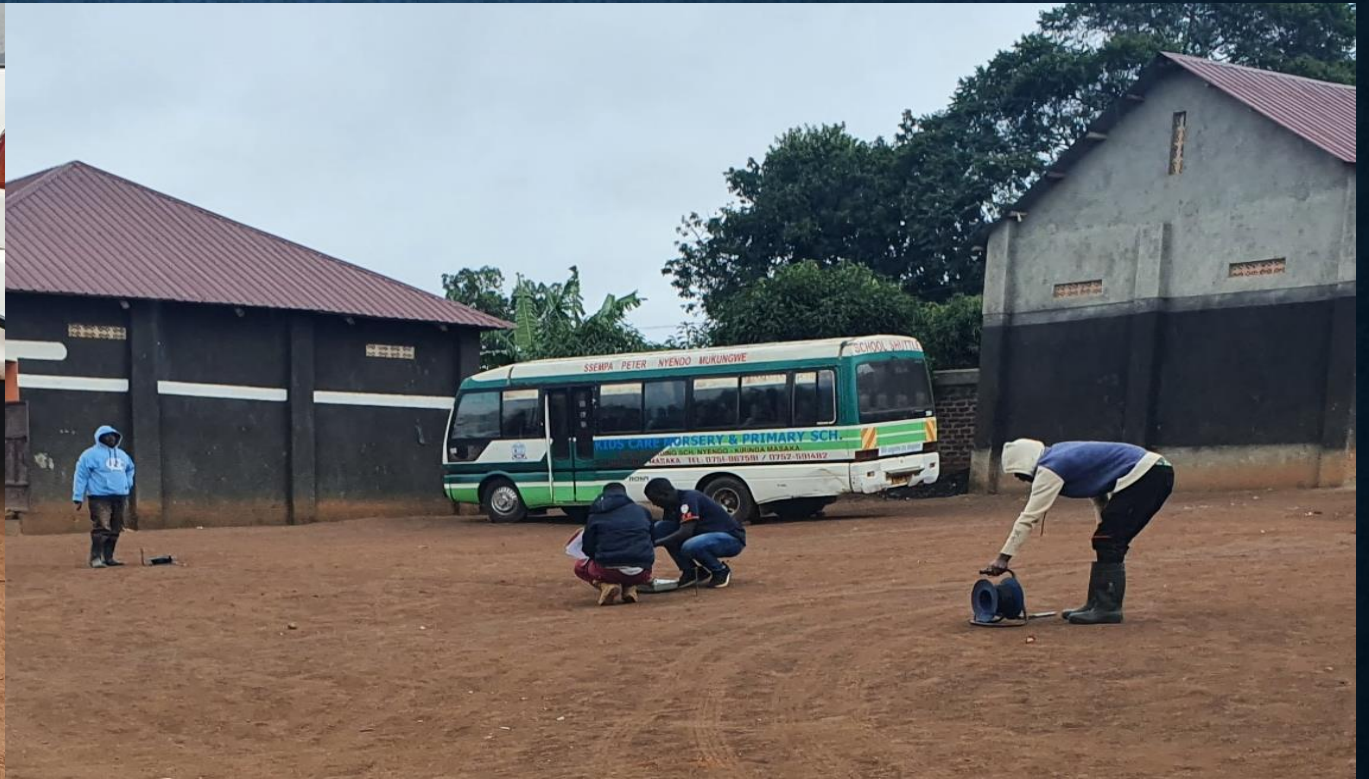
PHOTOS SHOWING GEOLOGICAL SURVEY

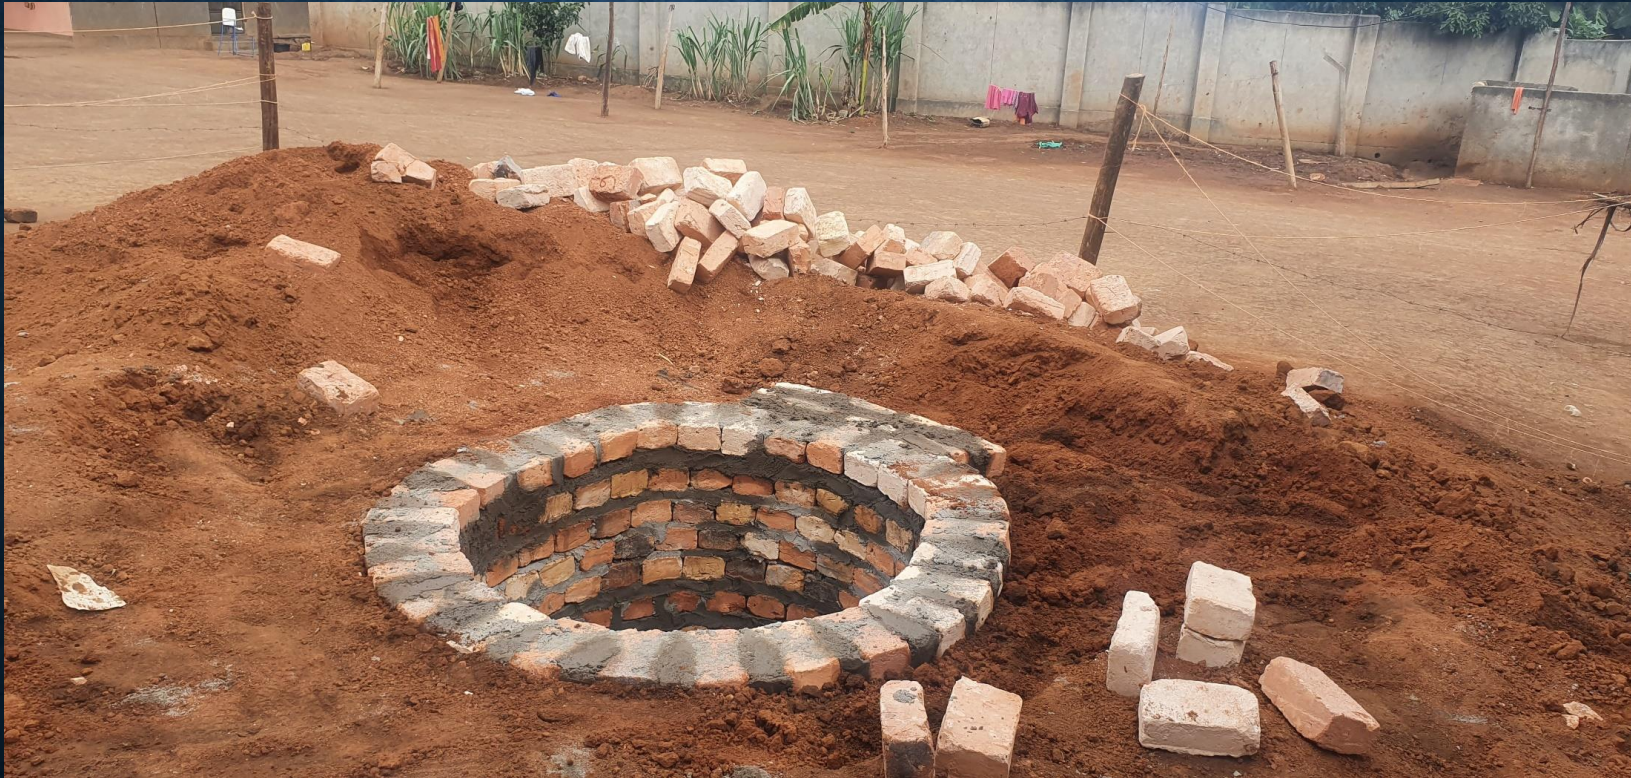
PHOTOS FOR CONSTRUCTION

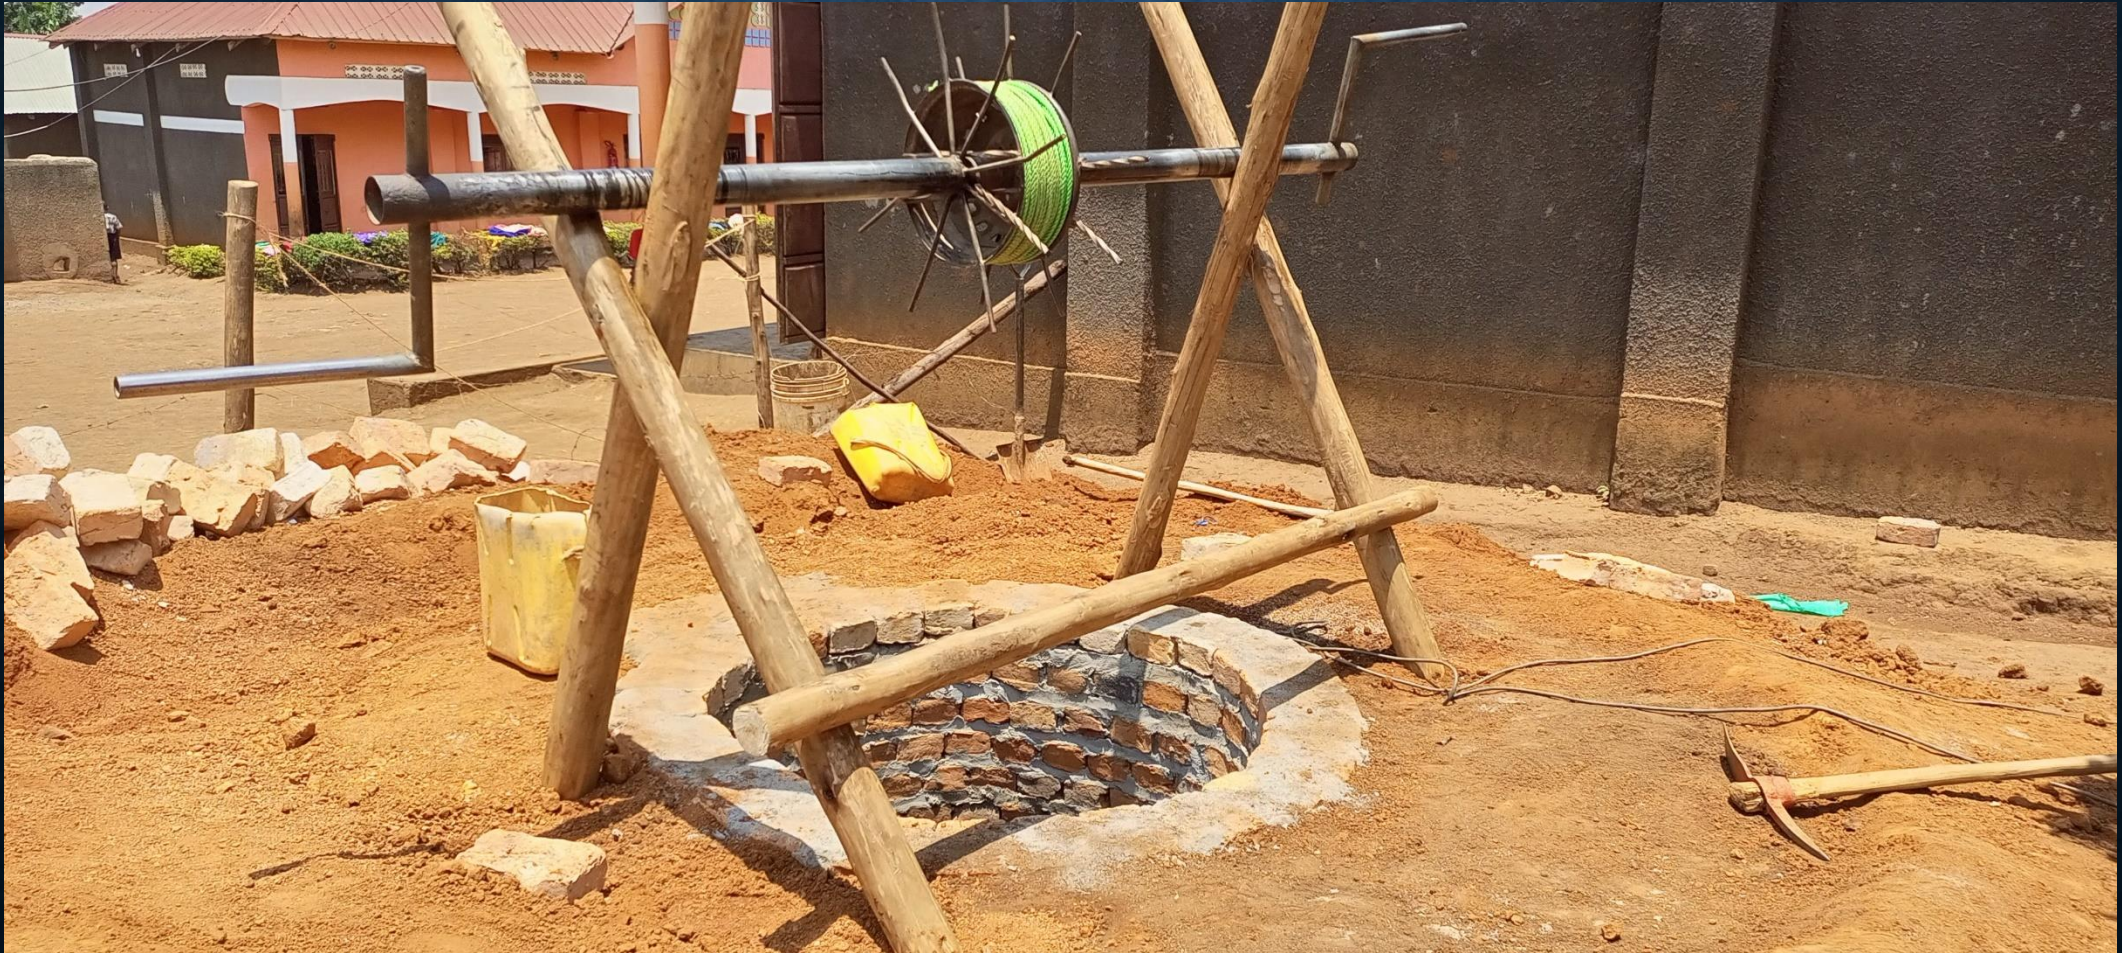
THE METALLIC ROLL WITH A ROPE FOR PULLING THE SOIL FROM UNDERGROUND

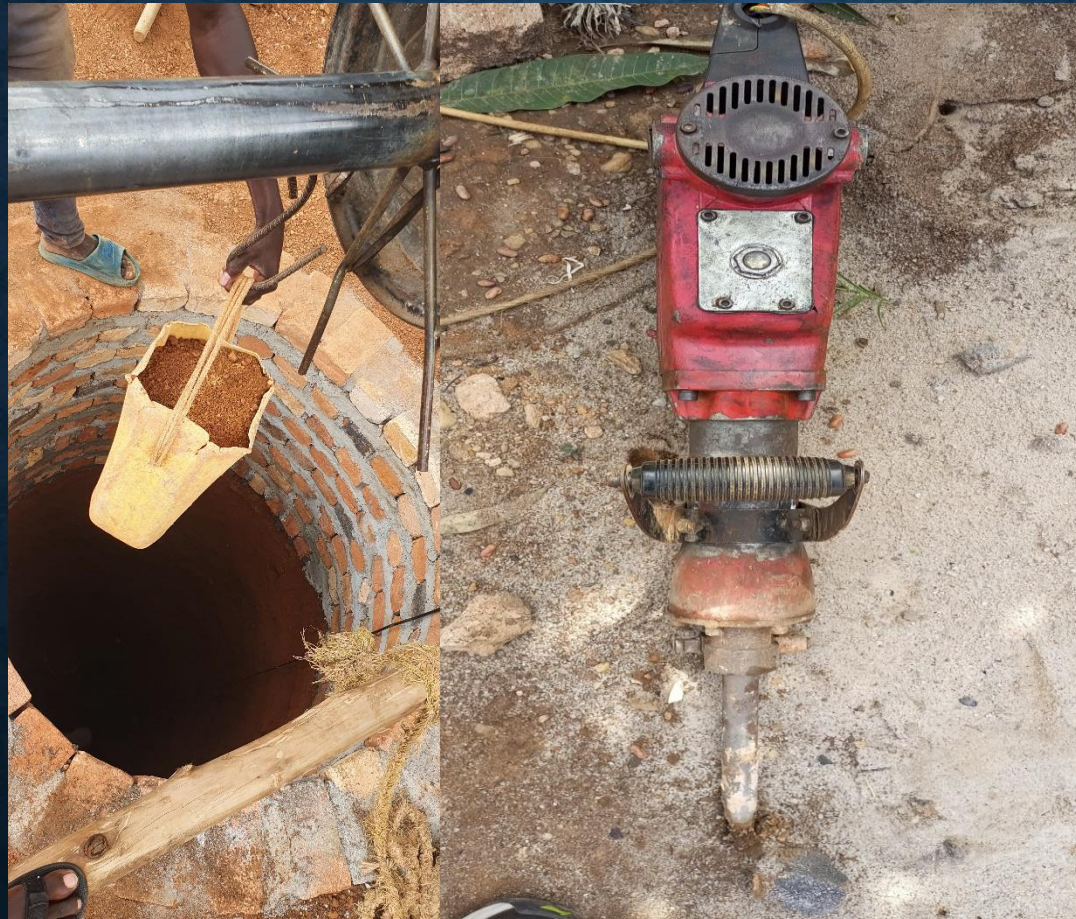
THE ELECTRIC HUMMER THAT WAS USED FOR BREAKING THE ROCK.

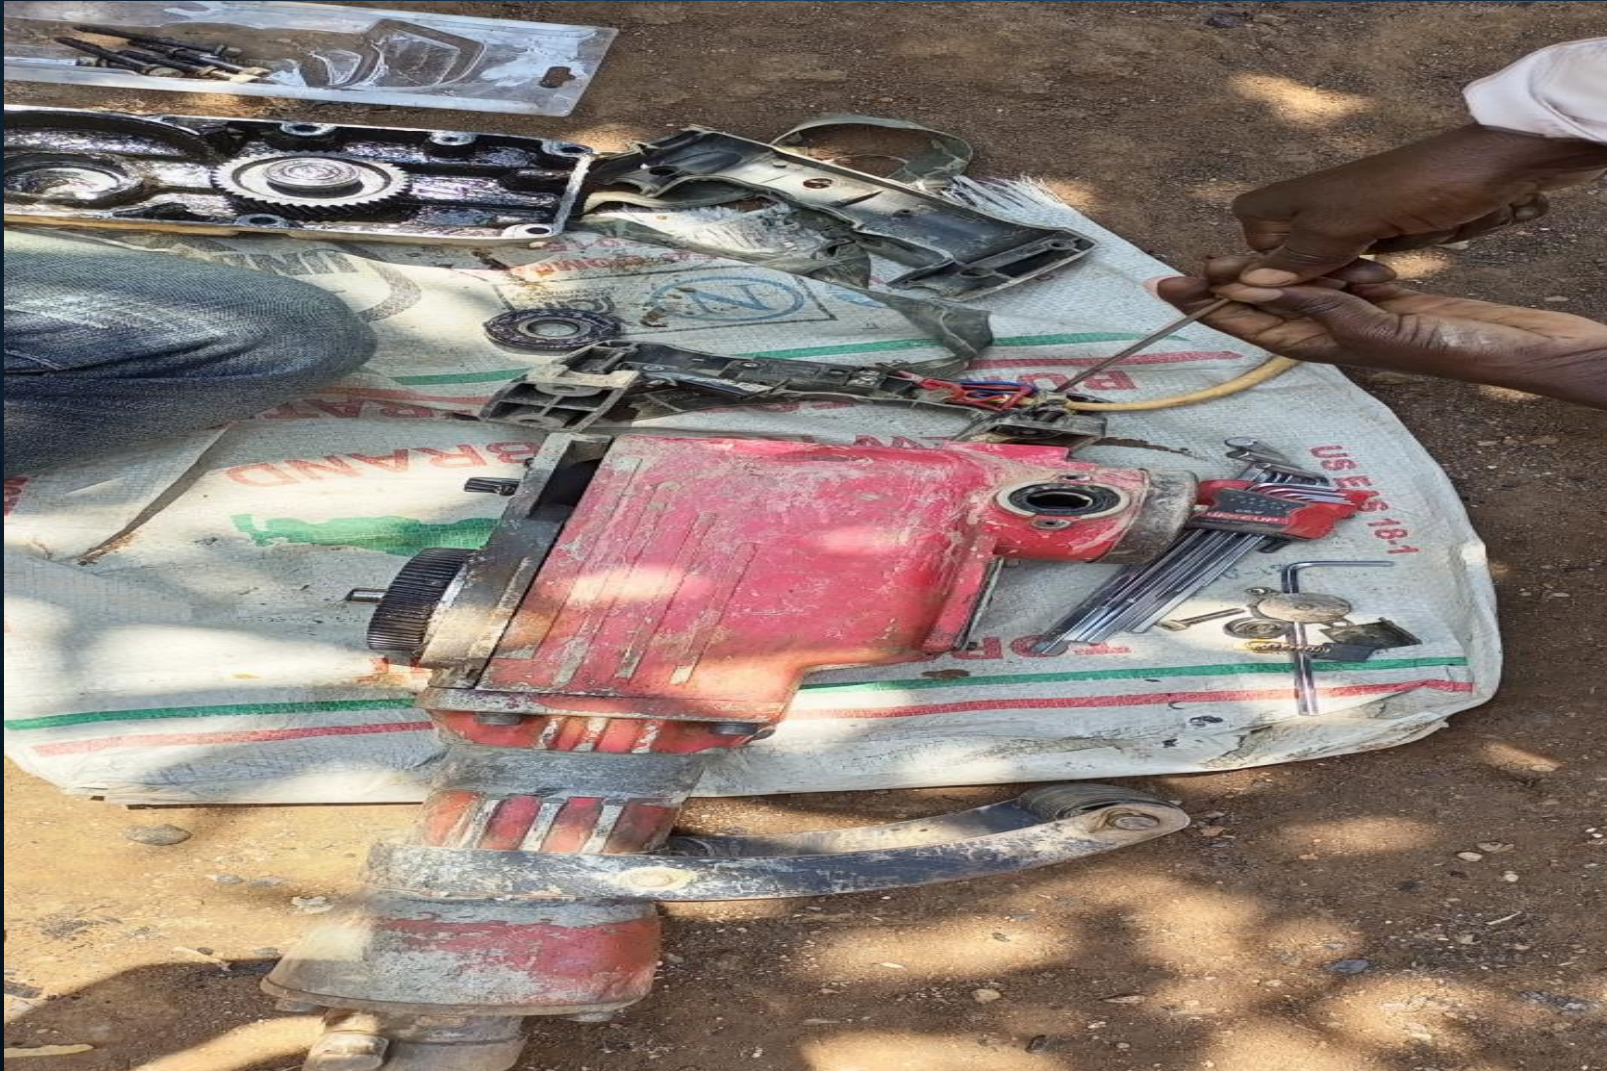
BREAKDOWN OF THE ELECTRIC HUMMER

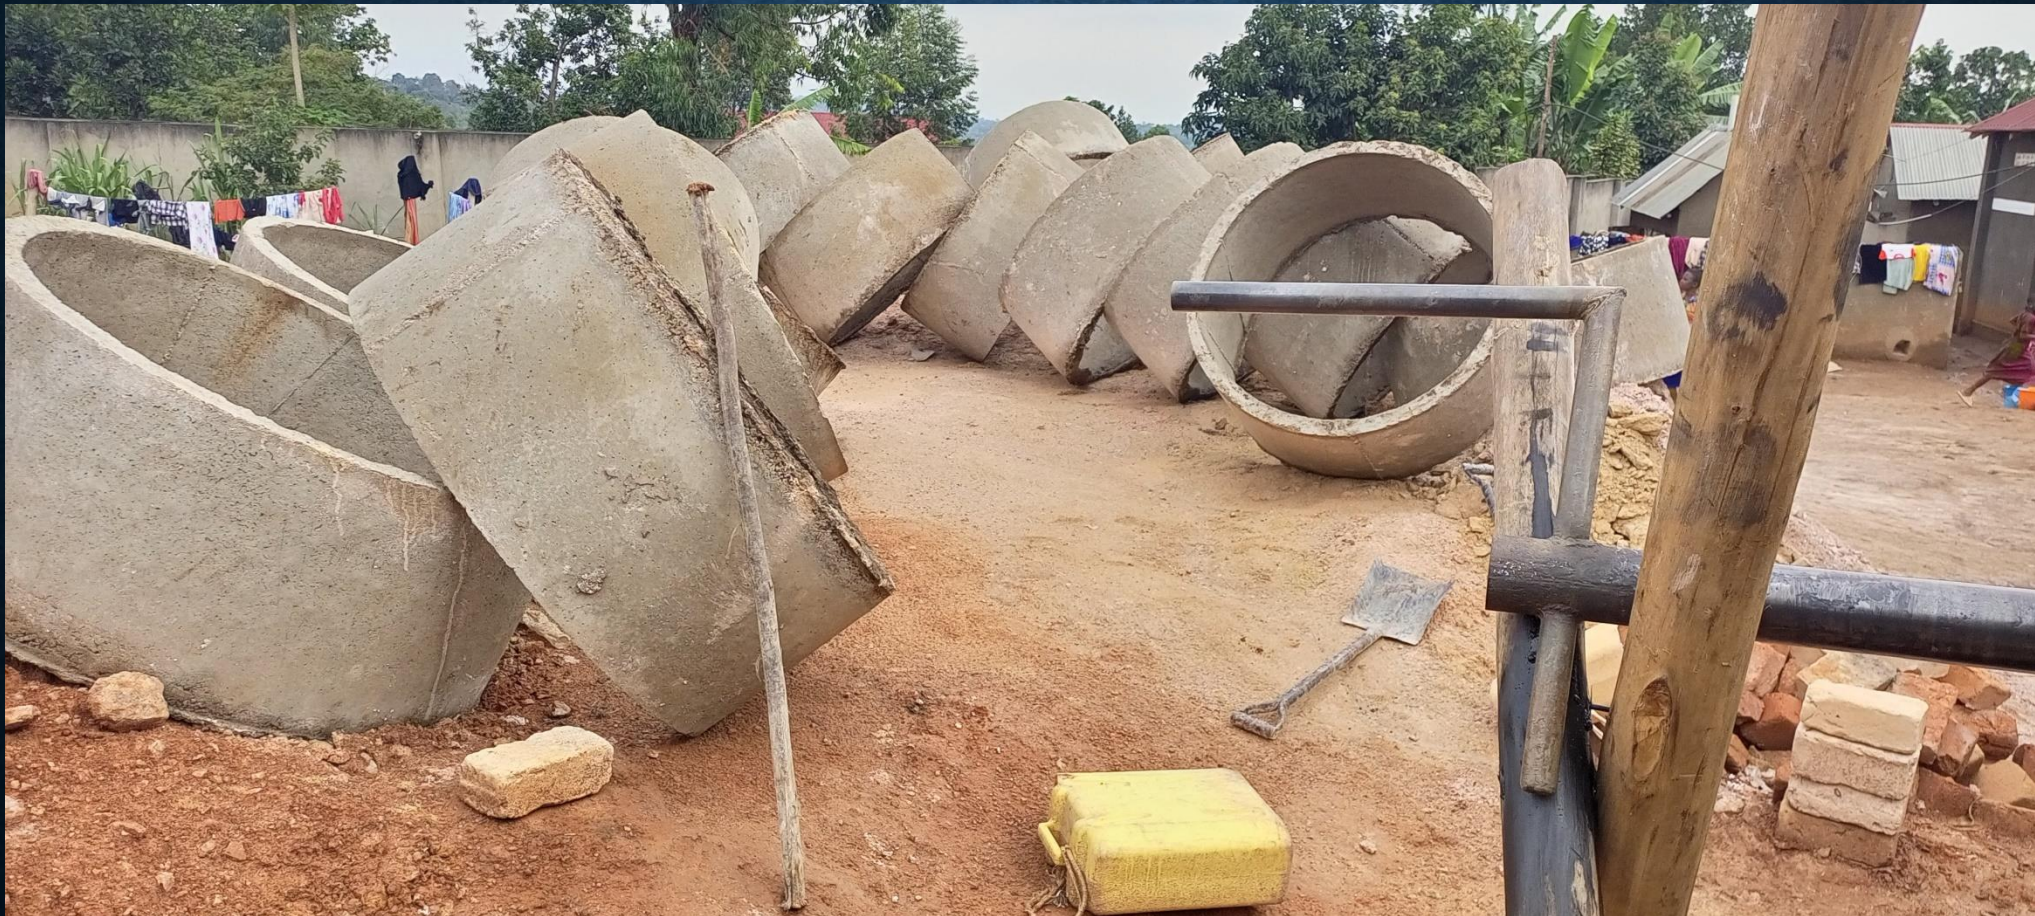
INSERTING OF RINGS IN THE WELL

- At the depth of 25 meters ,30 rings were inserted in the well ,to prevent collapsing soils from falling into the well and to control any accidents by the constructors.
- The rings didn't reach the top of the well because the remaining funds were not really enough to finish the remaining work such as to buy a solar system with a pump , install it and then on reaching the water at 36 meters ,the company had to dig further more to find better sources with more water ,this increased the cost and we decided to put rings up to 20metres .The chance is that there is a rock layer at near the top ,with advise from different experienced people , with the rocky layer and the 30rings inside well ,it cannot collapse.
- We found the better water sources at 45 meters and with this we can get enough water for use.
- The hole was closed with concrete to keep it safe from children .

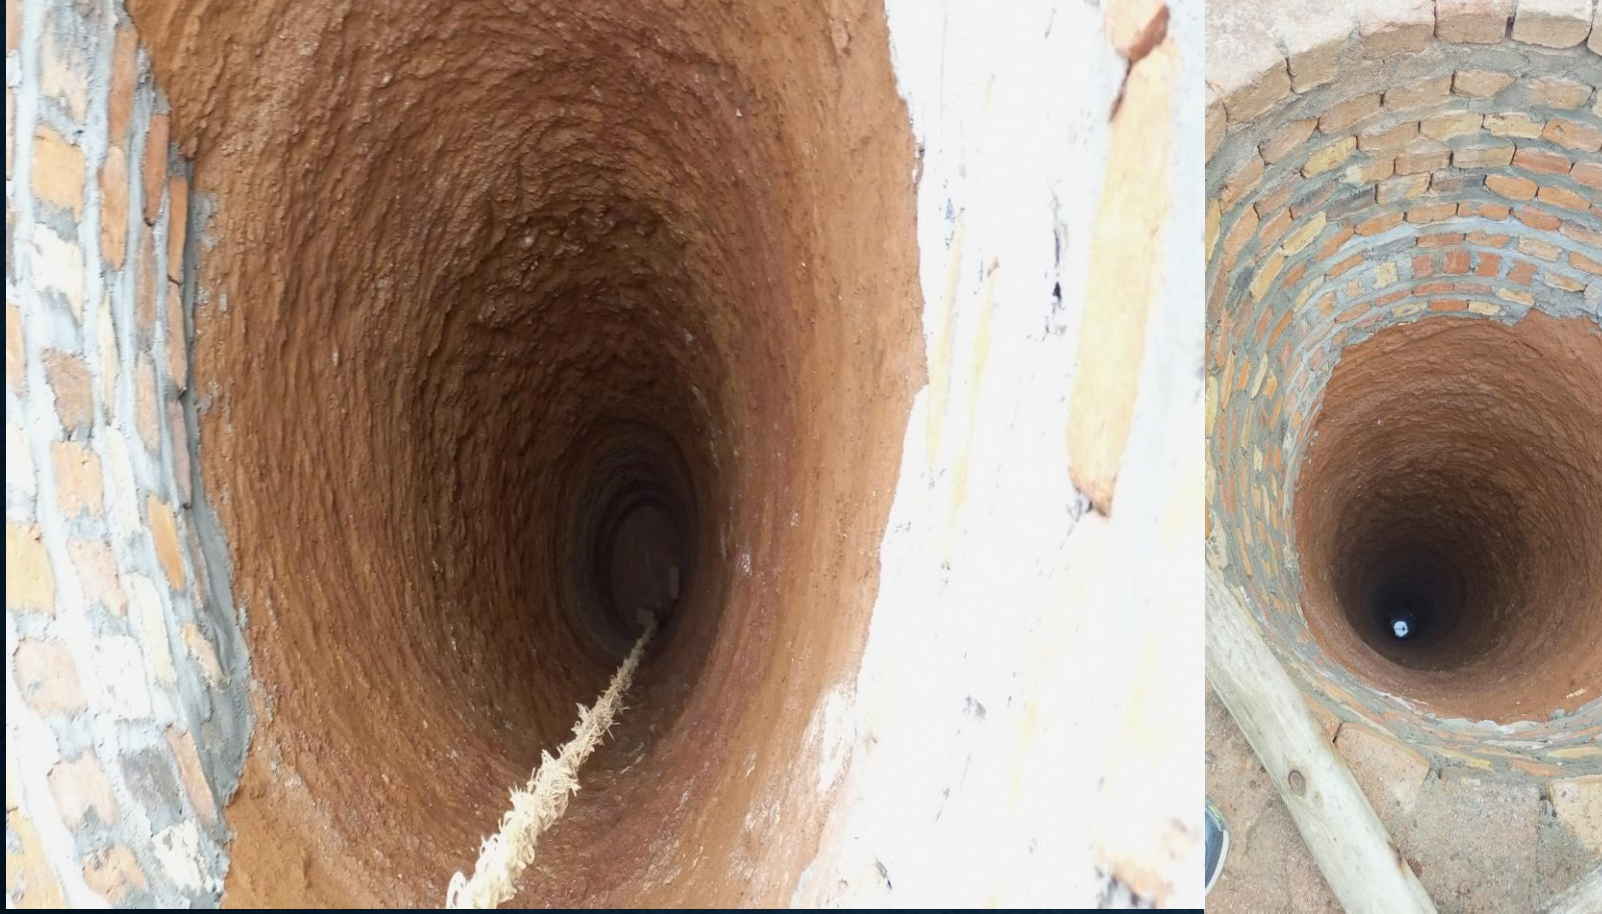
FIRST WATER SIGHT

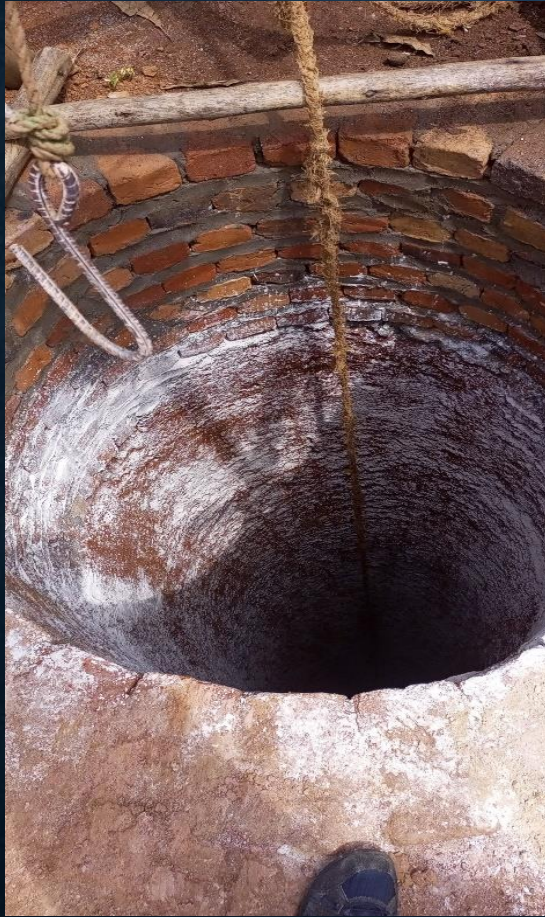
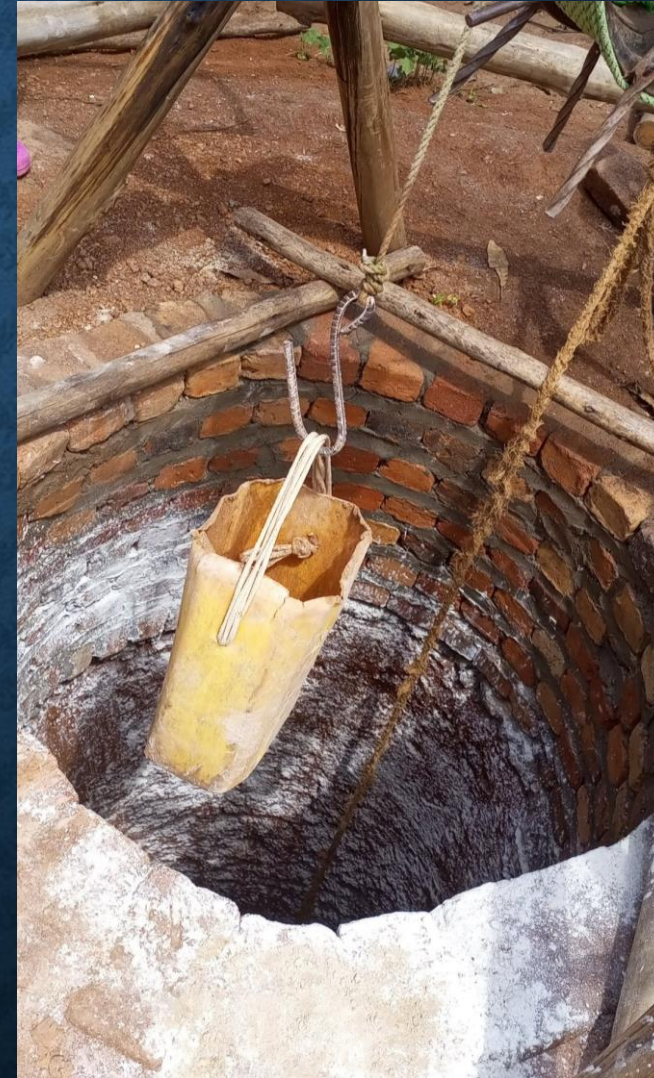
**THE WHITE SUBSTANCE IS LIME THAT WAS PUT ON
THE WALLS TO CONTROL LOSS OF OXYGEN DEEP
IN THE WELL.**

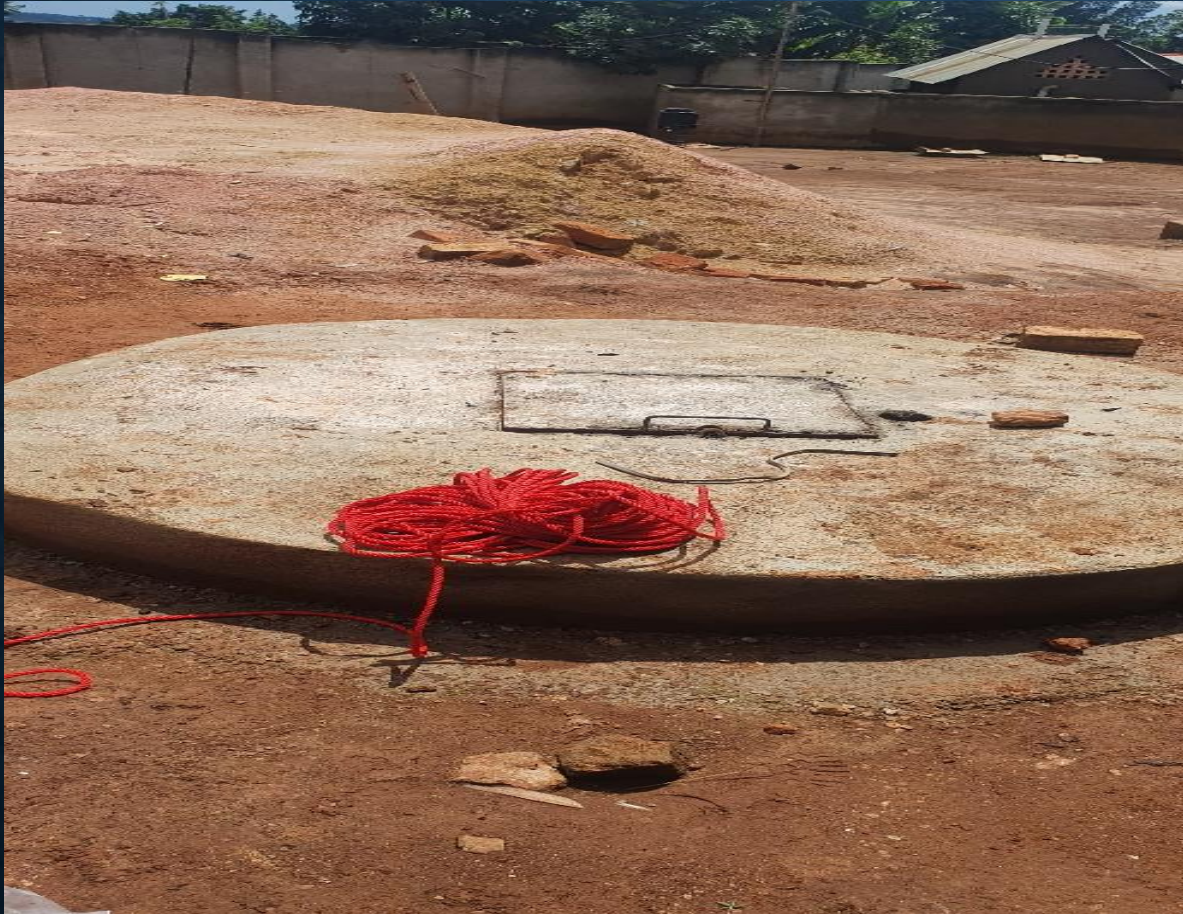
HOLE CLOSURE TO CONTROL ANY ACCIDENTS THAT WOULD OCCUR.

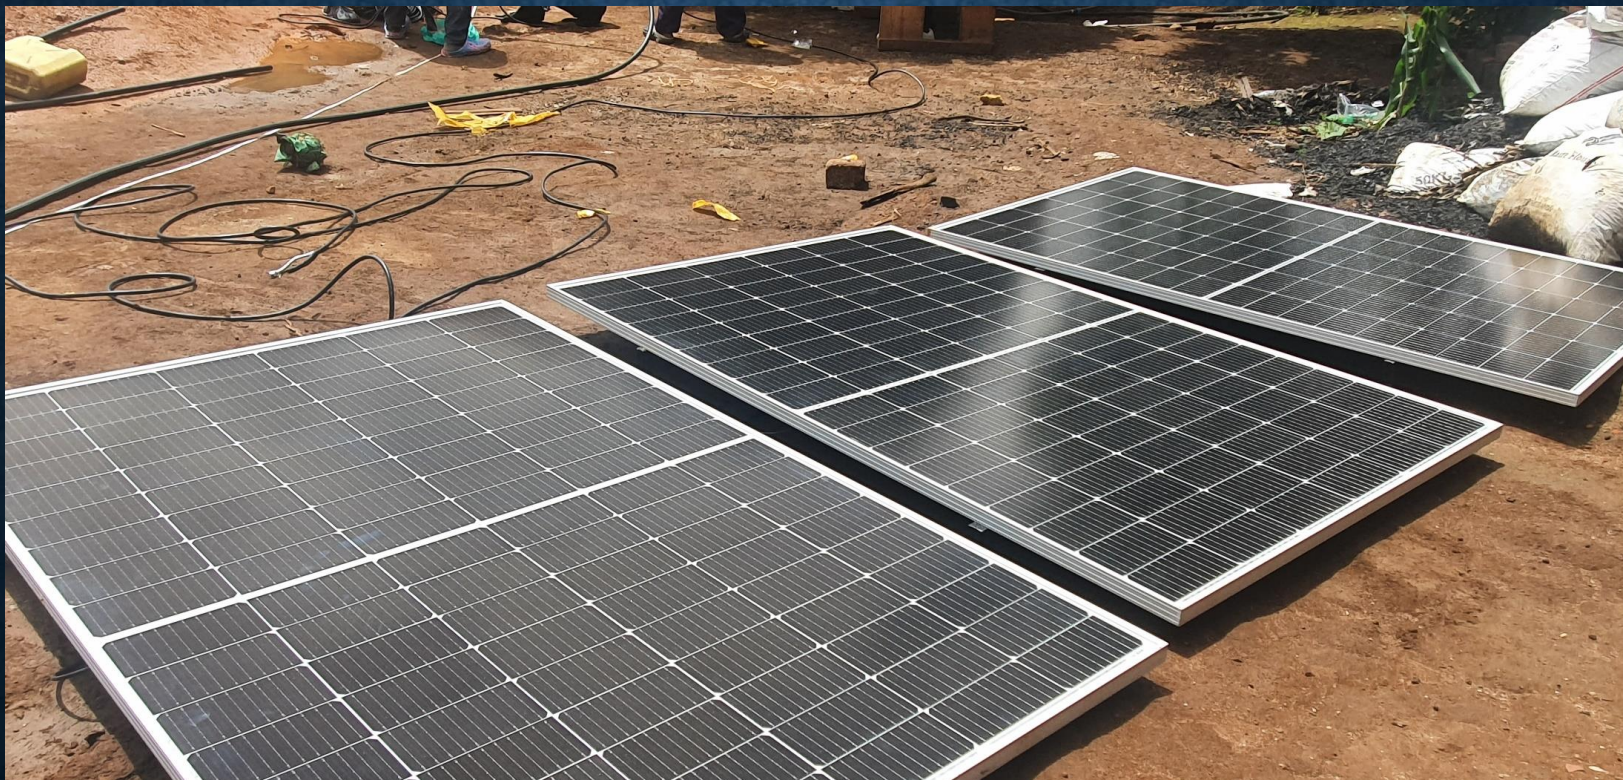
SOLAR PANEL AND PUMP

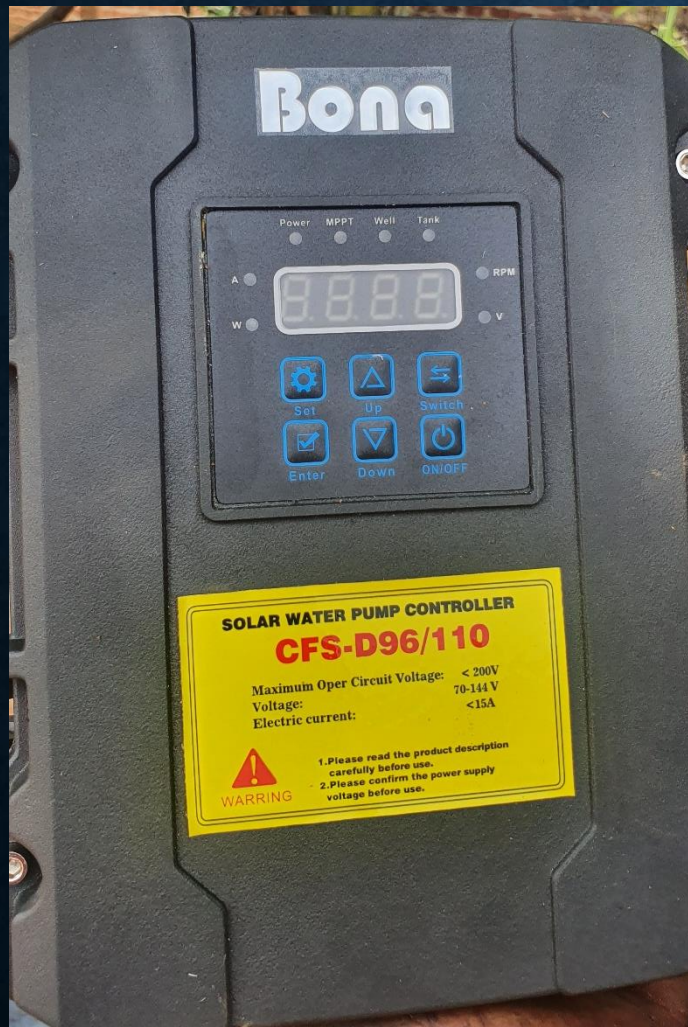
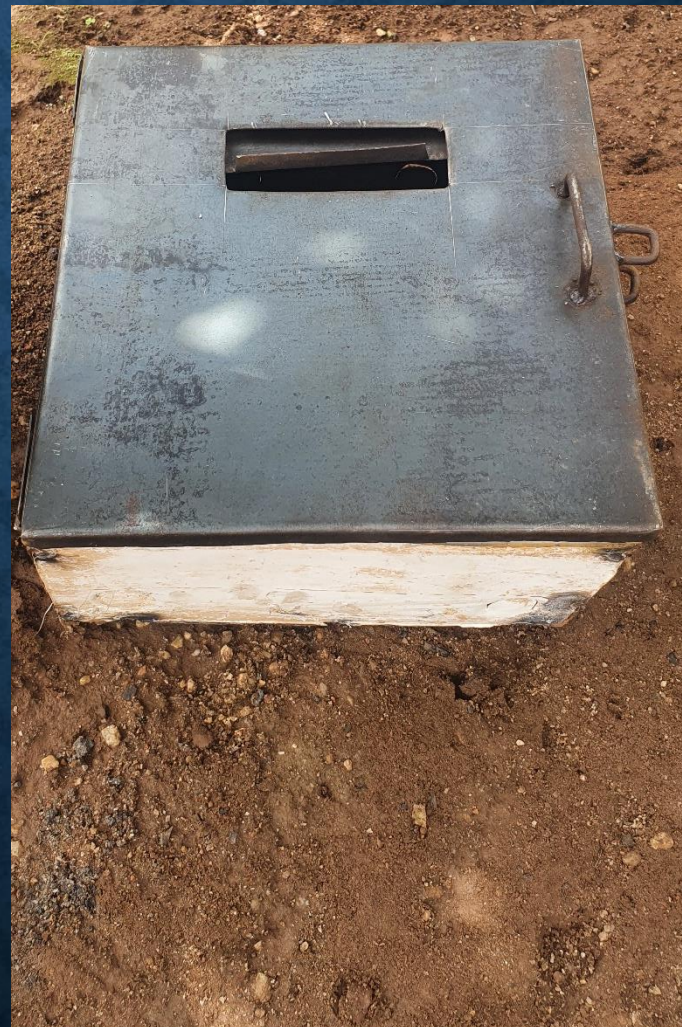
CONTROL SYSTEM AND METALLIC BOX TO KEEP IT SAFE.

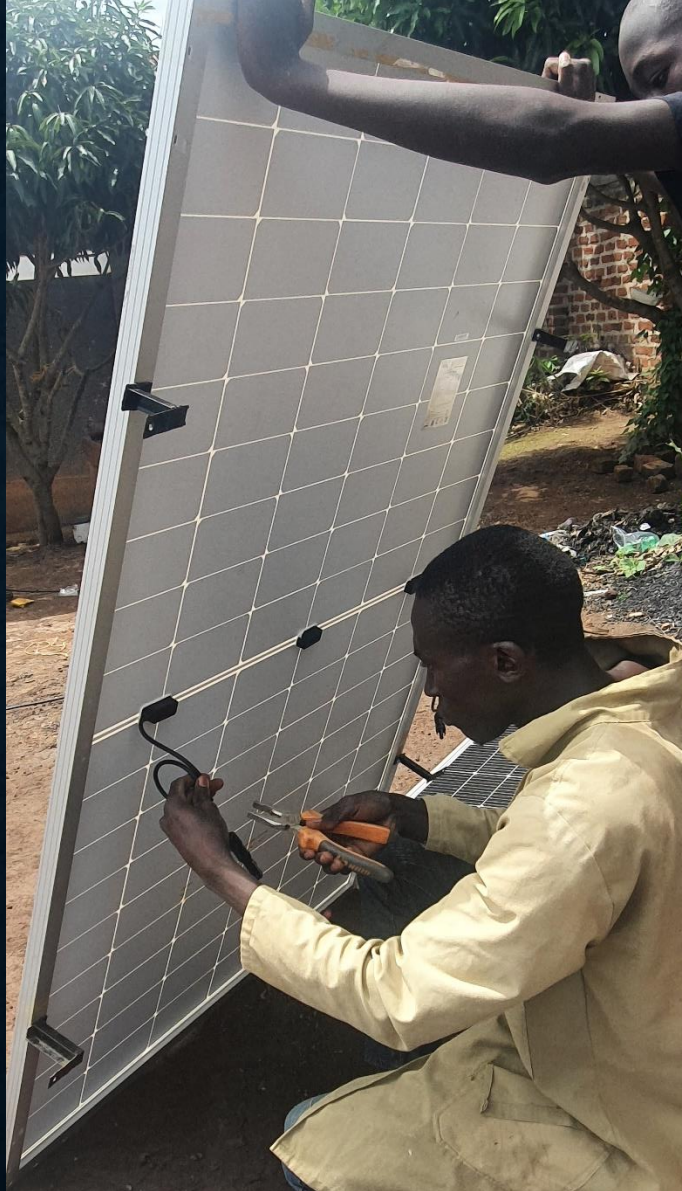
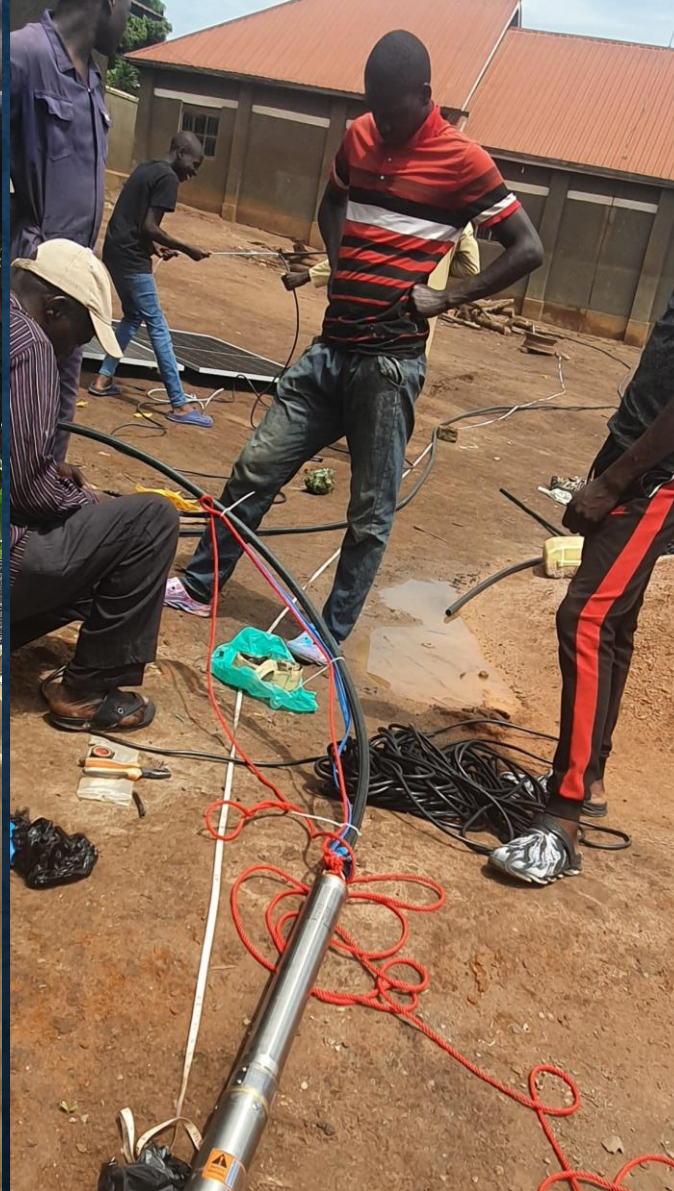
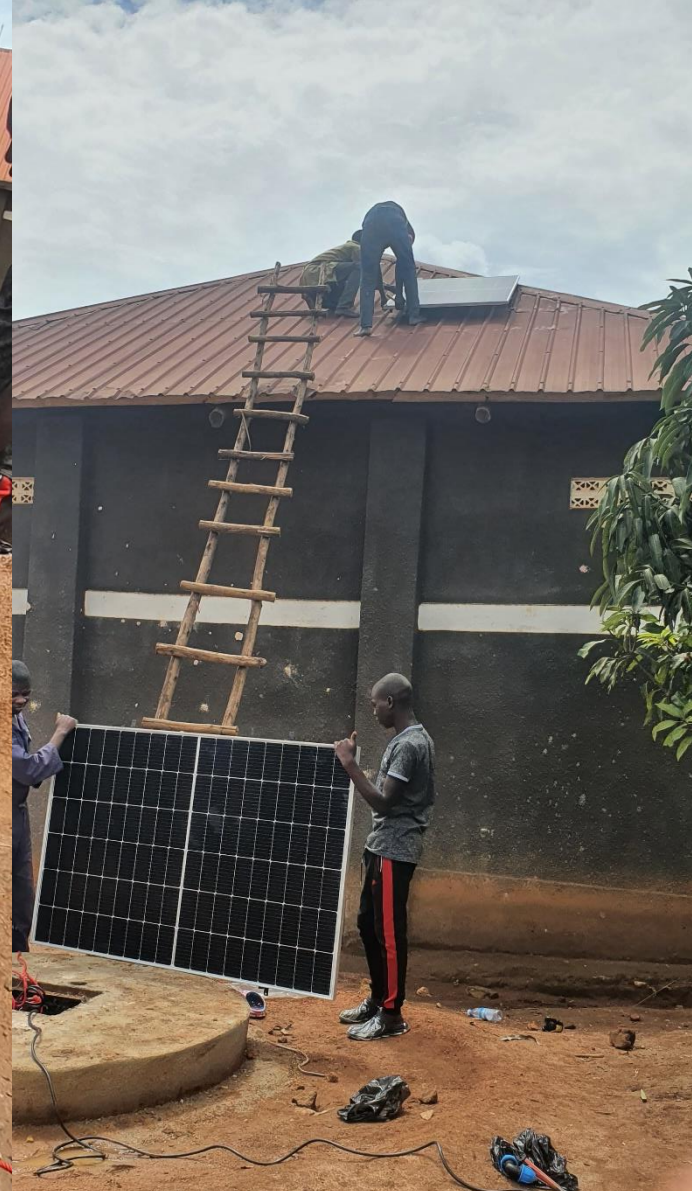
WIRING

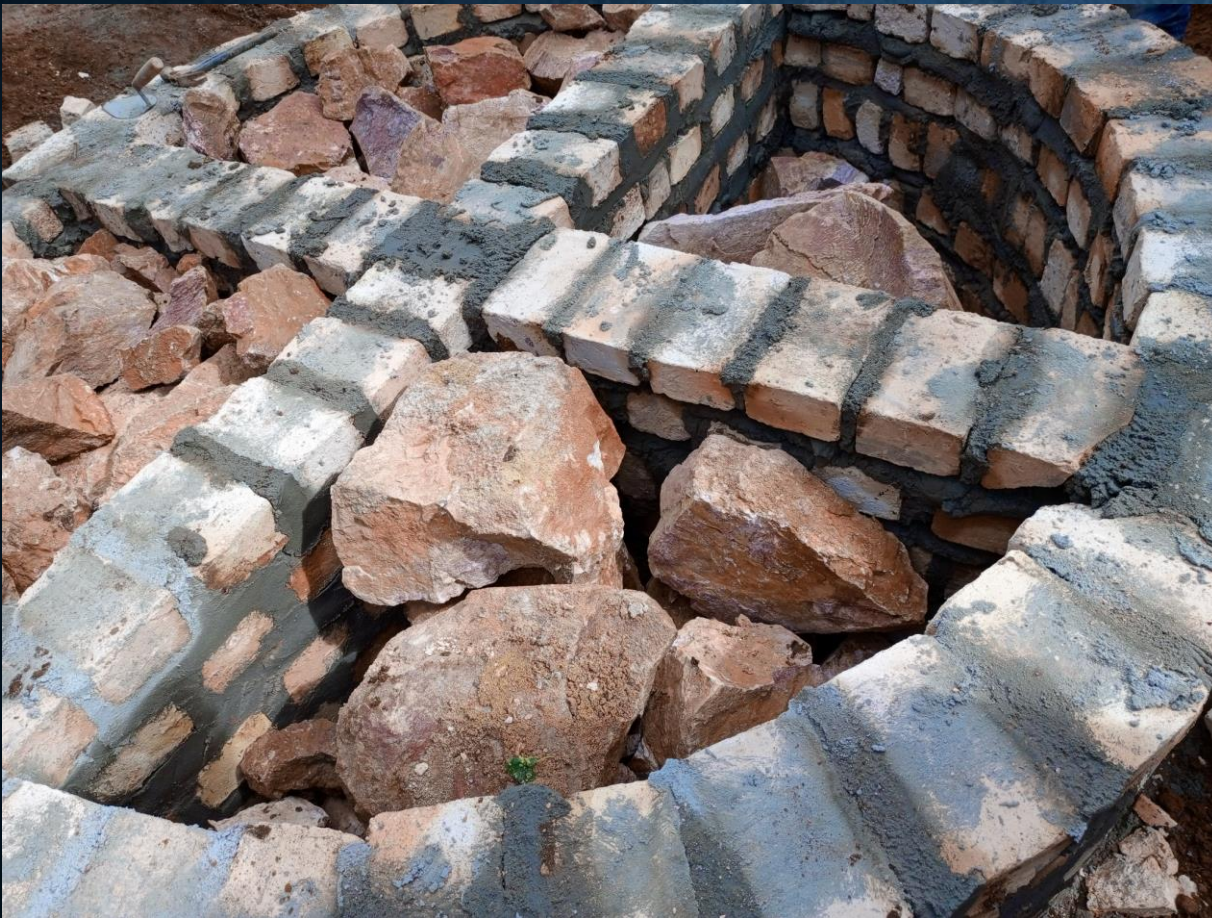
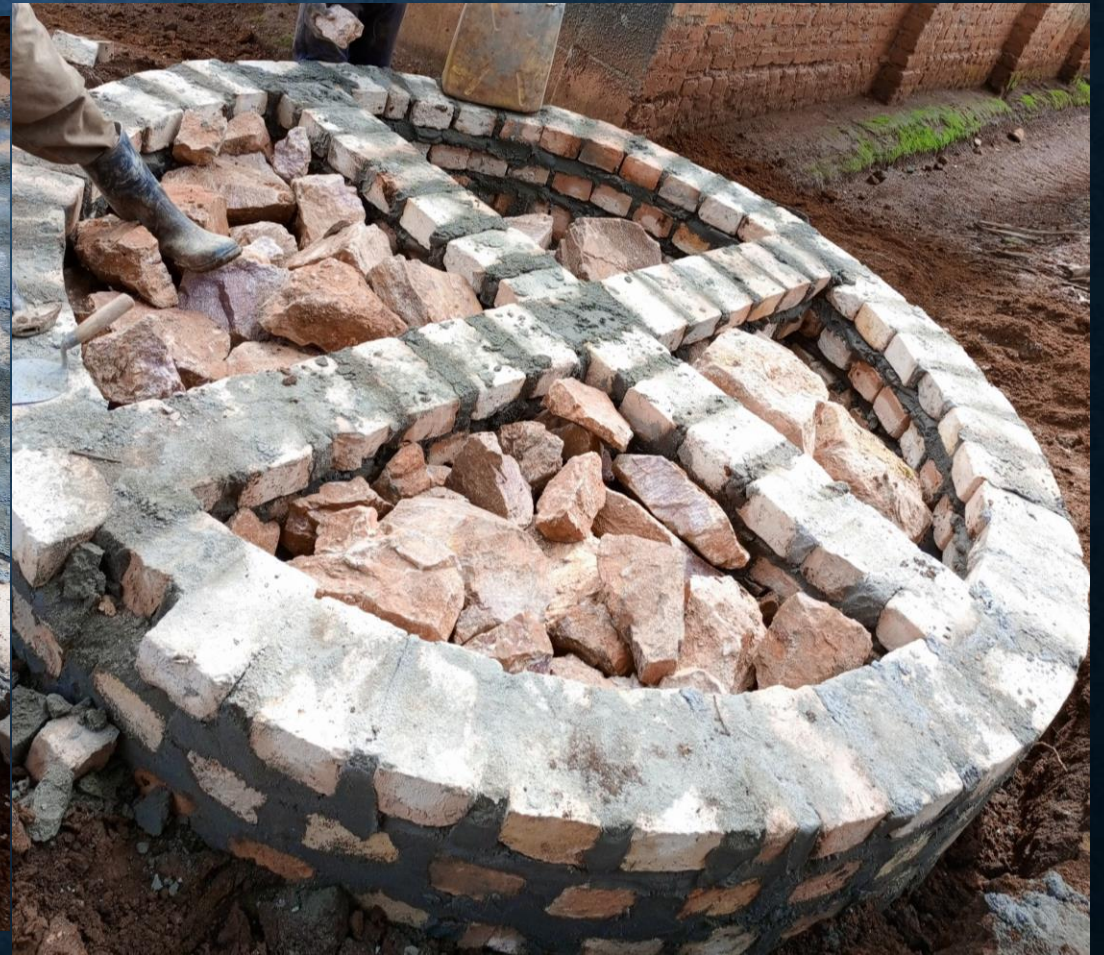
CONSTRUCTION OF THE TANK SEAT

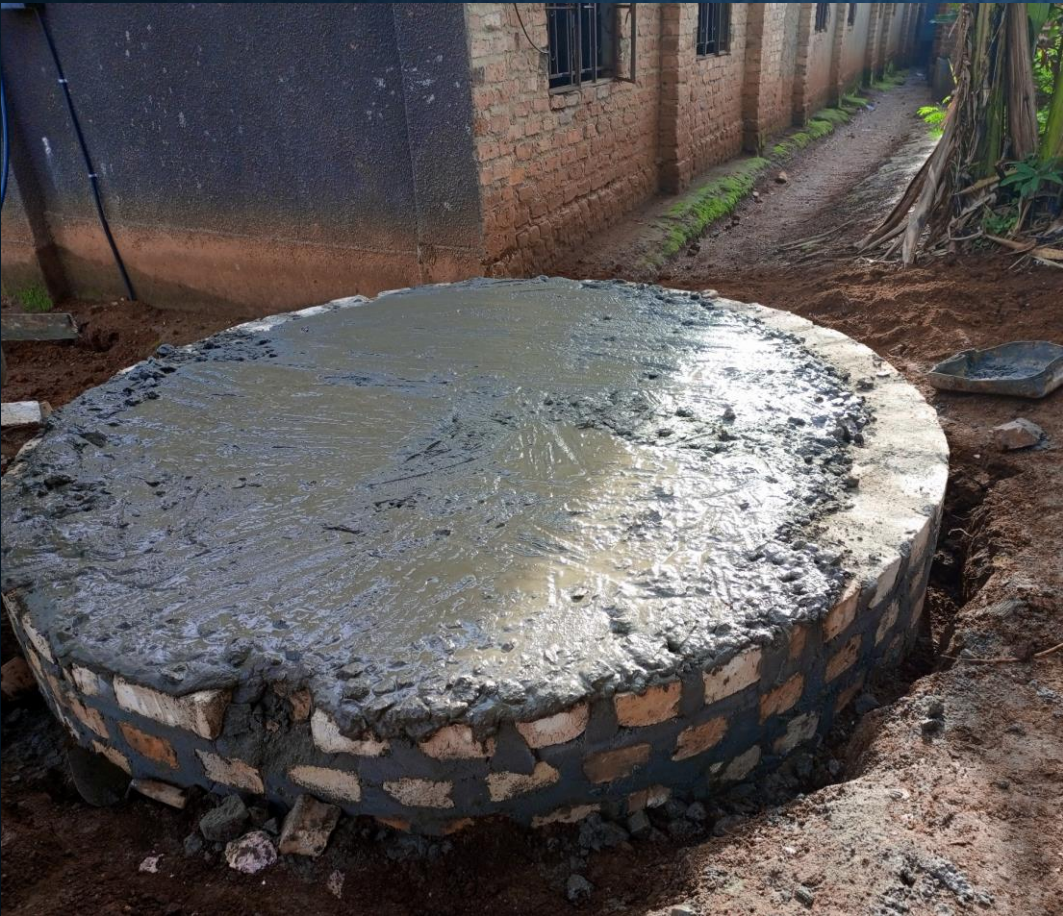
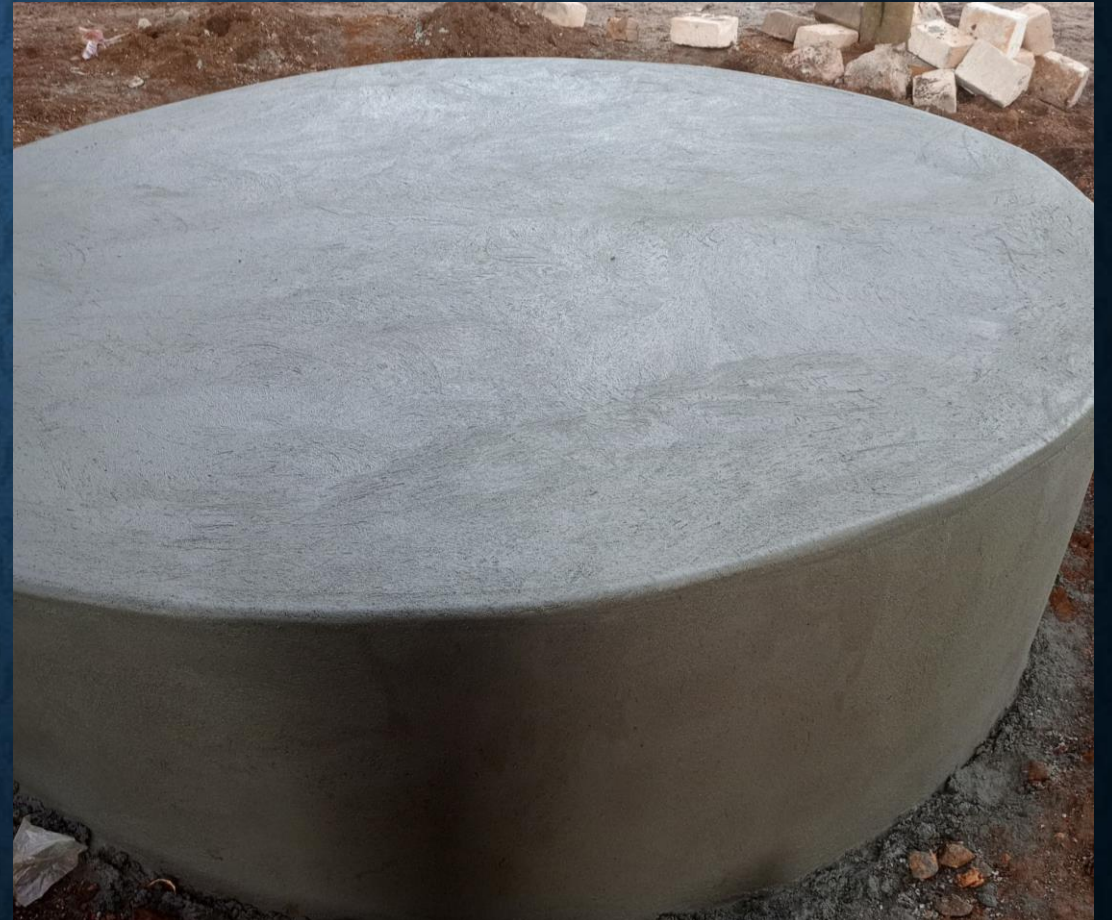
ACCOMPLISHMENT OF THE TANK SEAT
