A REPORT FOR THE WELL AT KIDSCARE PRIMARY SCHOOL ON 12TH SEPTEMBER 2021

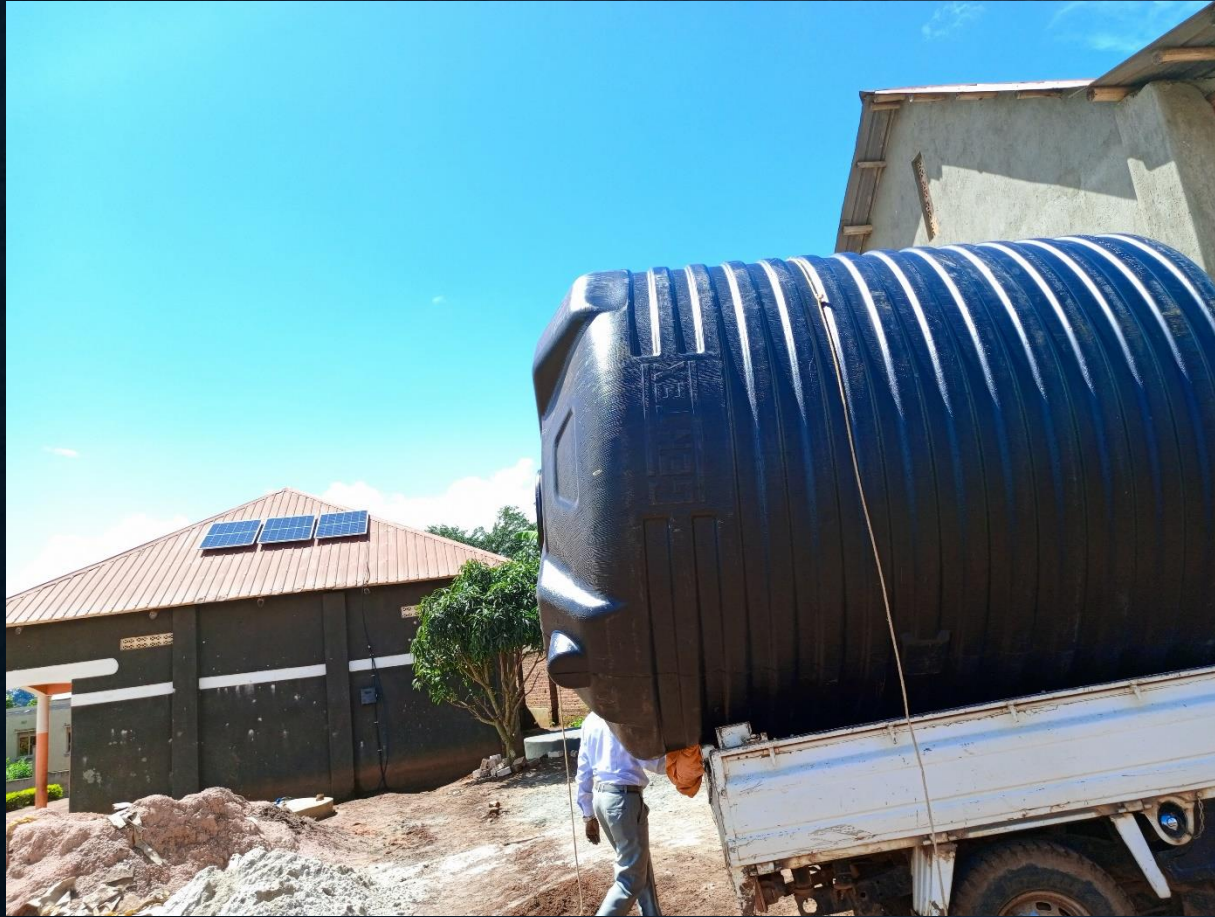
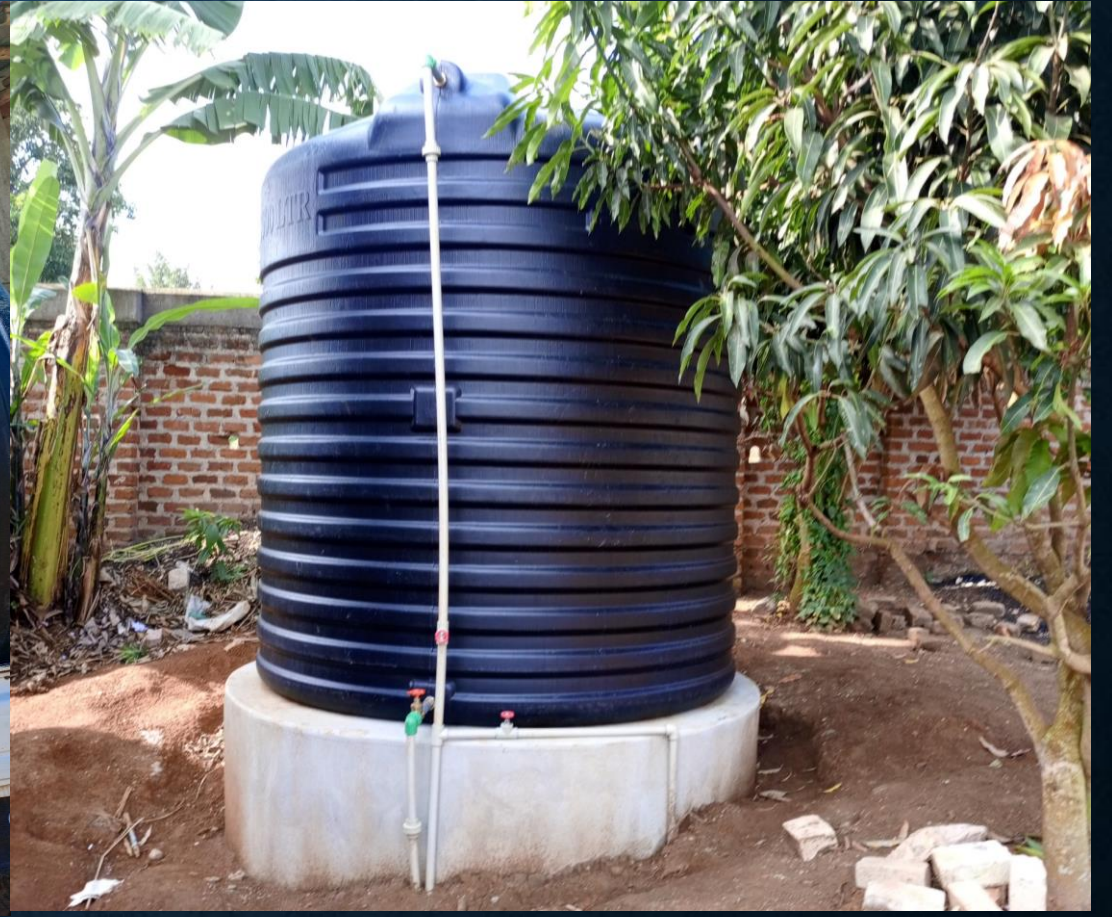
INSTALLATION OF THE TANK

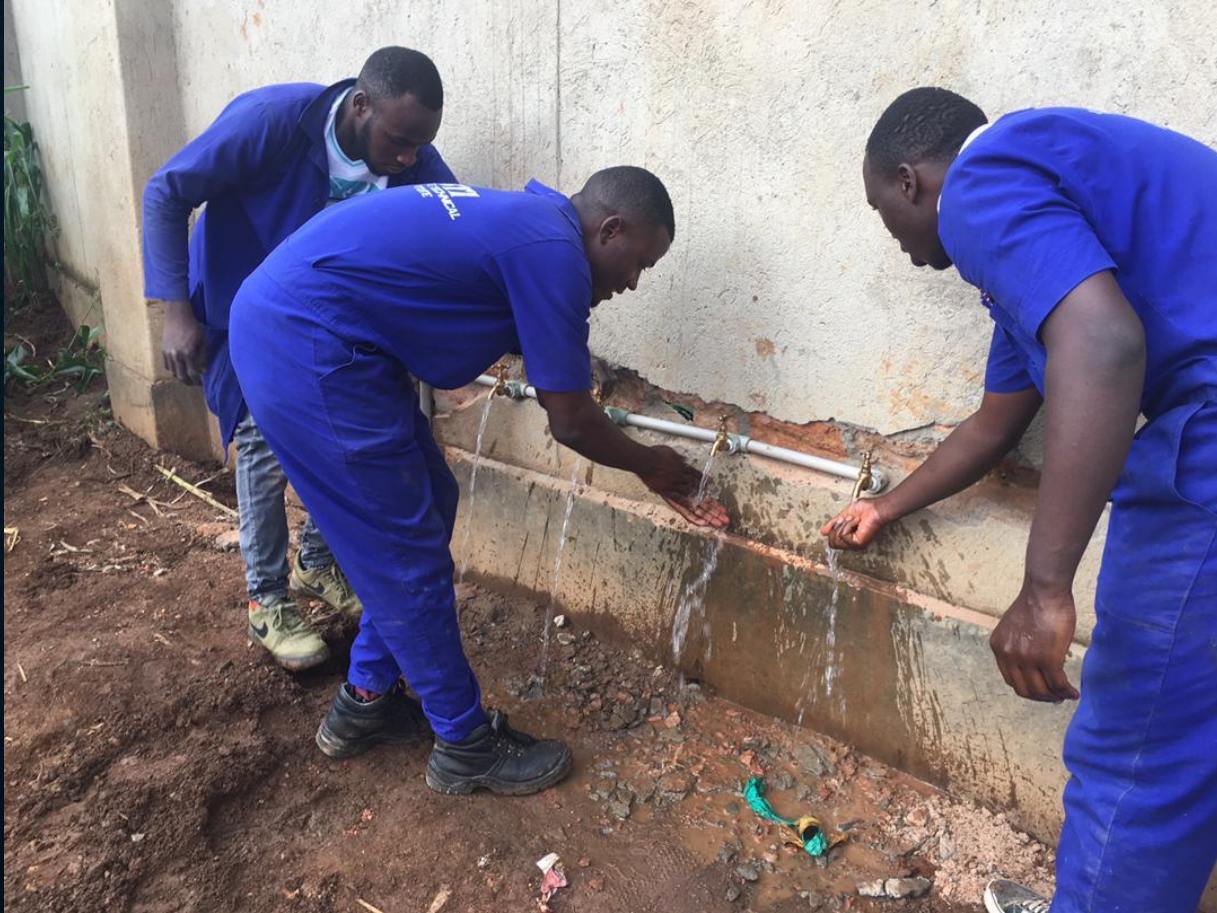
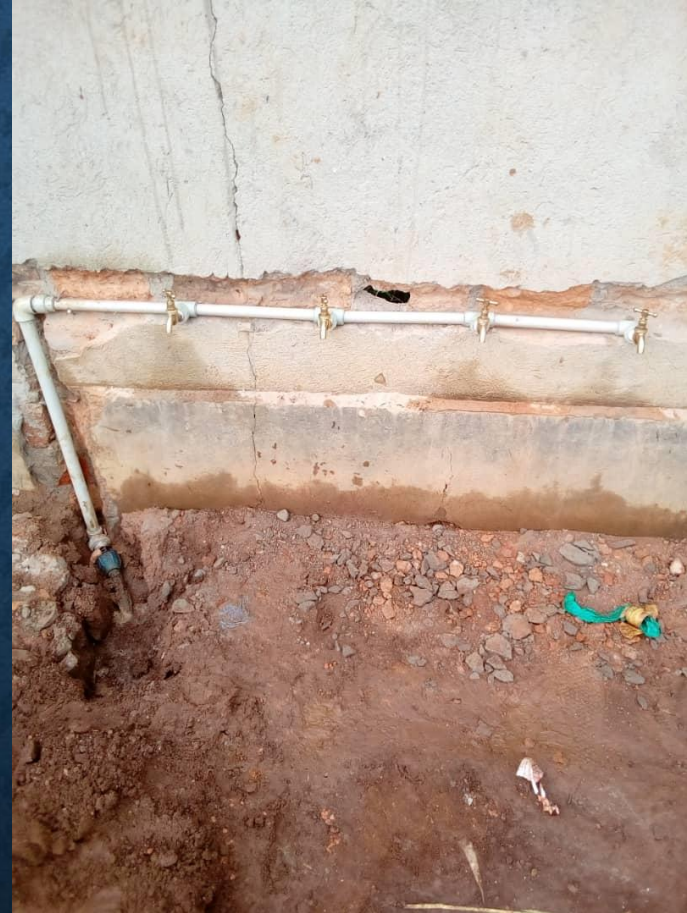
WATER POINTS

- The last part of the construction started :
- This involved installing the solar ,building the tank seat , putting the tank and building tap points for water collection.
- We were able to also build different water points ,four taps at the boys dormitory and four taps at the girls dormitory for easy collection of water when needed .
- Another pipe was connected from the pump direct to the tank for drinking water .

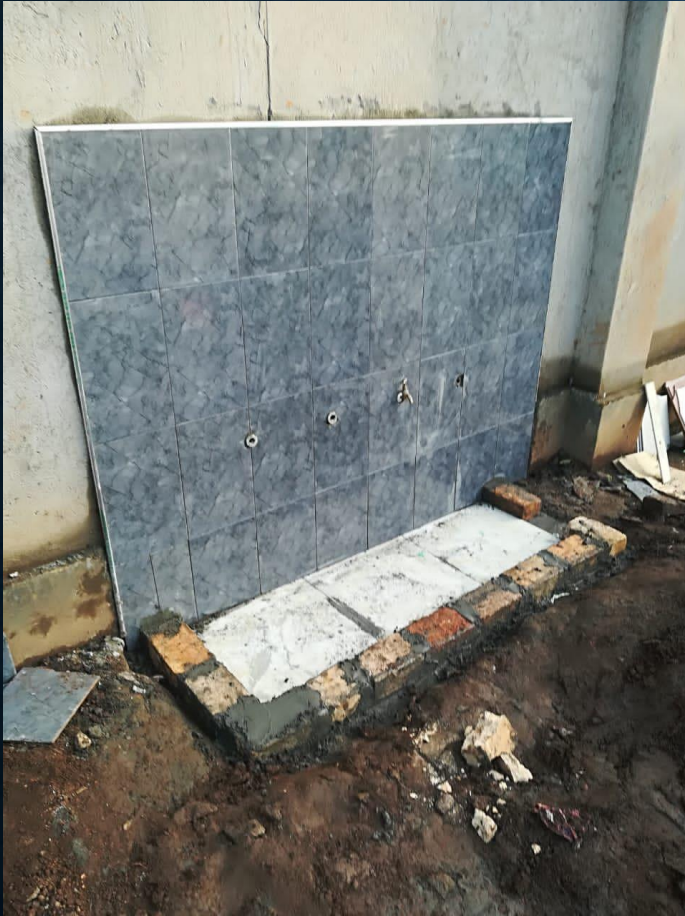
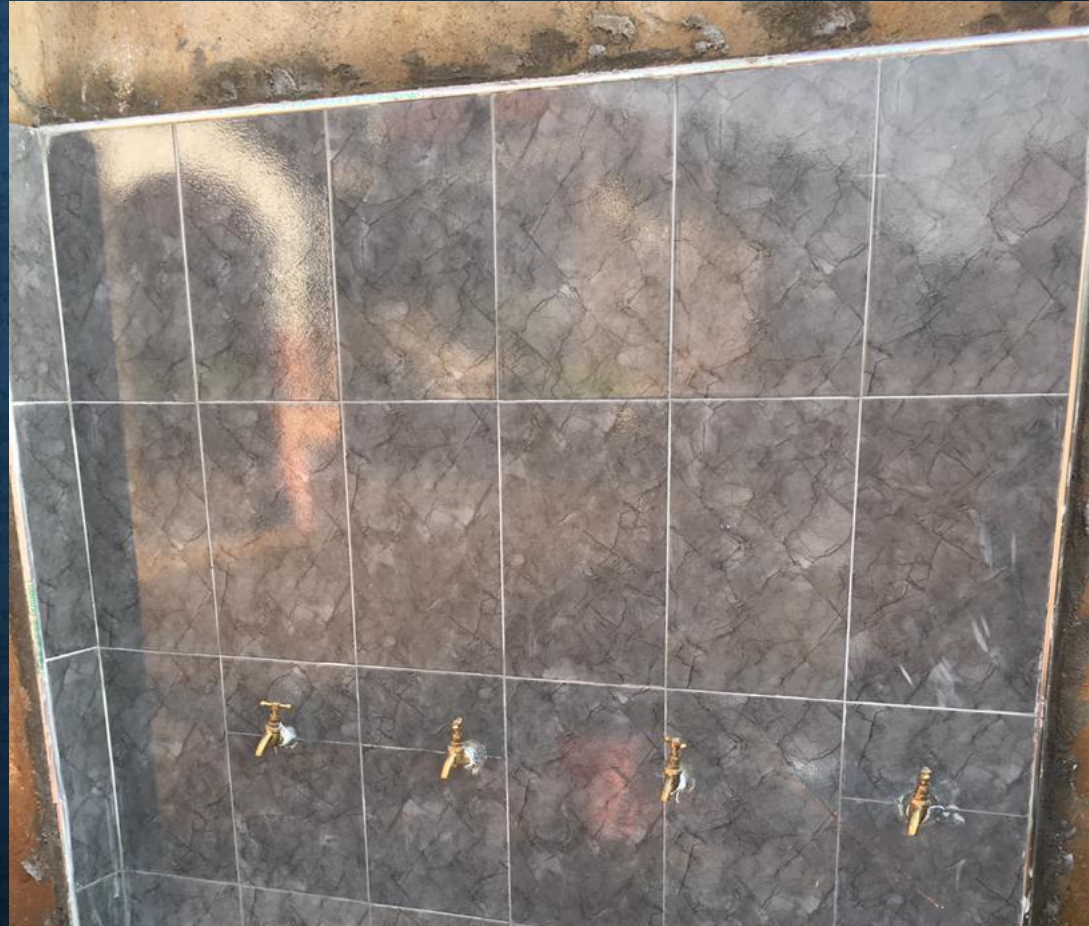
**AROUND THE WATER POINTS ,TILES WERE BUILT
TO CONTROL WATER FROM WEAKENING THE
WALL WHICH COULD LEAD TO ITS FALLING.**

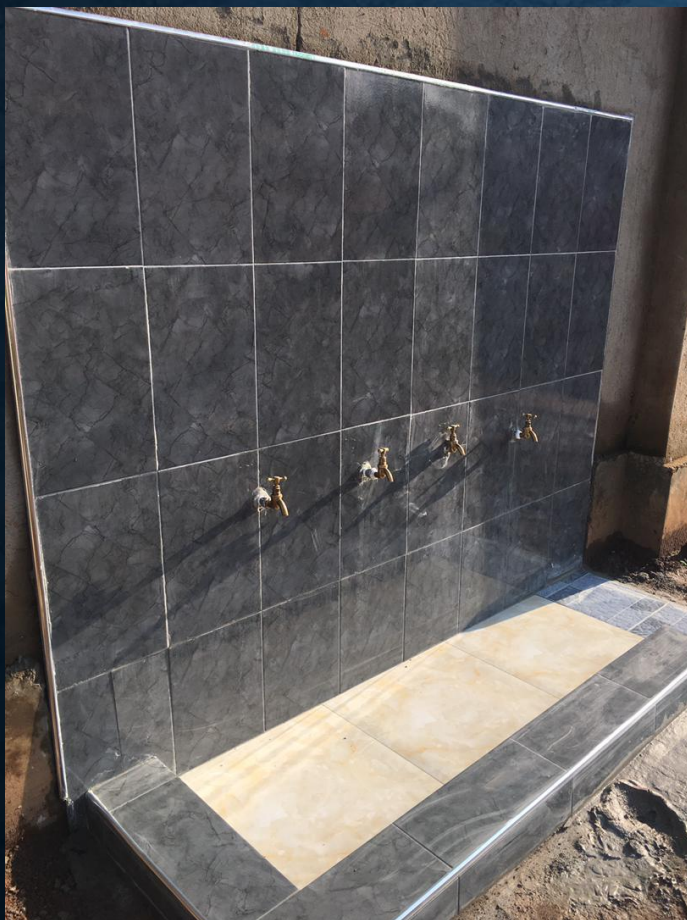
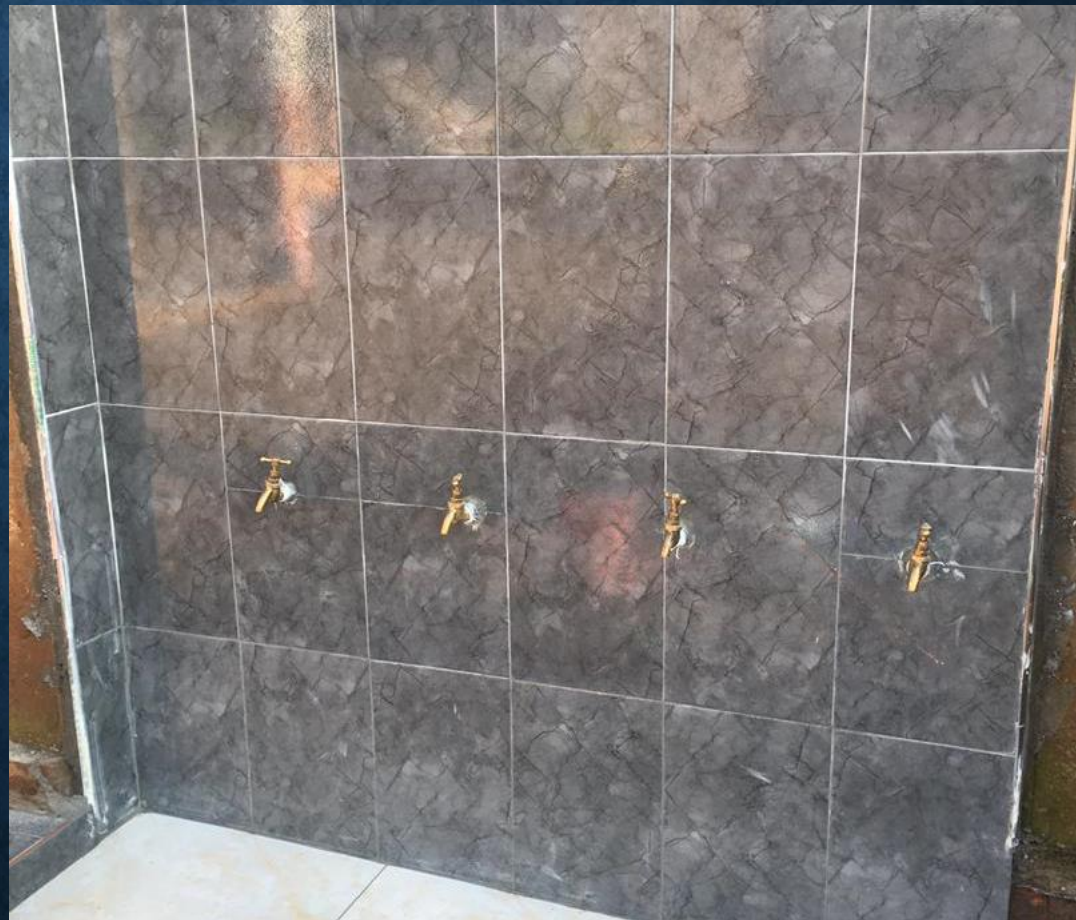
**THE SCHOOL DONATED THE WHITE TILES
THAT WERE PUT ON THE FLOOR.**
